## **Quebecor World Applies Software Emulation in Press Control Console Upgrade**

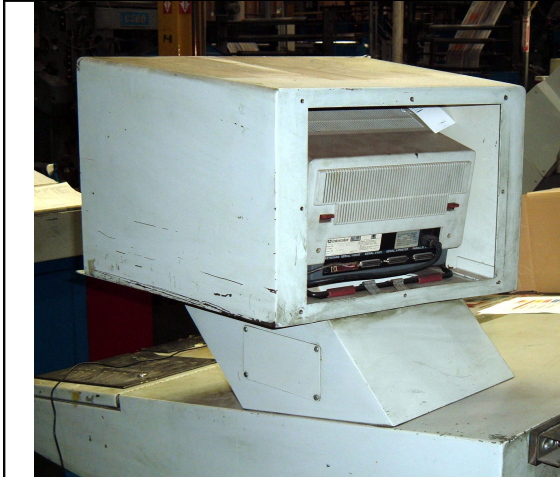
Rear view of one of the press control consoles at Quebecor World's Riverside plant showing the original Intecolor 3810 terminal prior to removal and replacement.

To further simplify Mike’s installation task, Mirador included a serial communications cable adapter that would allow Mike to connect the new hardware to the other Goss console components without making any wiring changes. All Mike would have to do would be to disconnect the RS-232 communications cable at the rear of the old Intecolor CRT and reconnect it by way of the adapter to the new hardware.

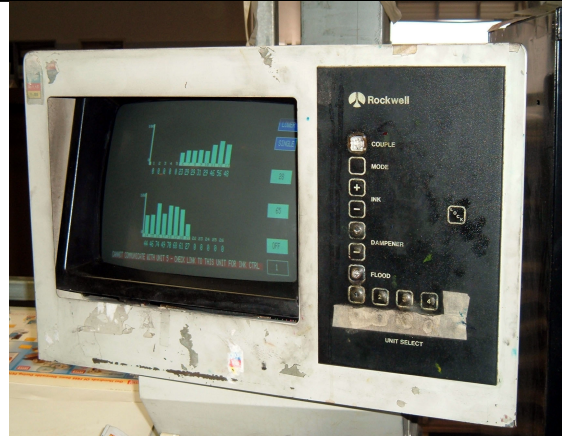
Front view of the press control console showing the original Intecolor 3810 terminal ready for removal from the rear.
